REB-BUILT Project

*Rehabilitation of the Built Environment in the Context of Smart City and Sustainable Development
Concepts for Knowledge Transfer and Lifelong Learning*

RE-BUILT - SOFIA, BULGARIA - 02.2020 Days for the REBUILT Construction Sector

Days for the REBUILT Construction Sector
A RE-BUILT Project Workshop Supporting the Built Environmental Rehabilitation in Europe
Sofia, 17 - 27 February 2020

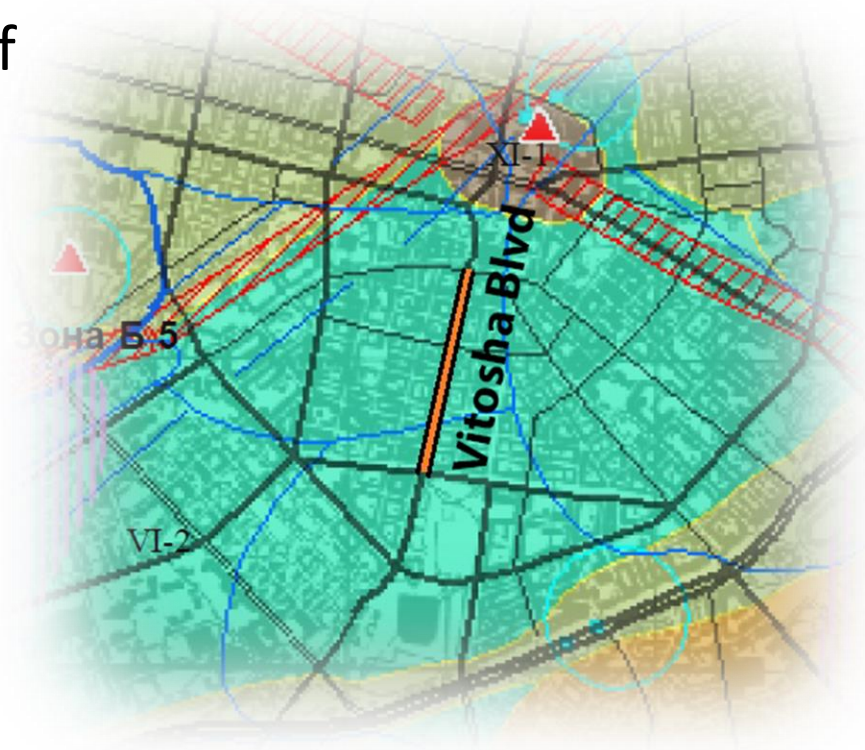
Geological features of the studied area

- soil below the section consists of Alluvial clays and gravel;
- relatively high groundwater level;
- predisposition to liquefaction during the earthquake.

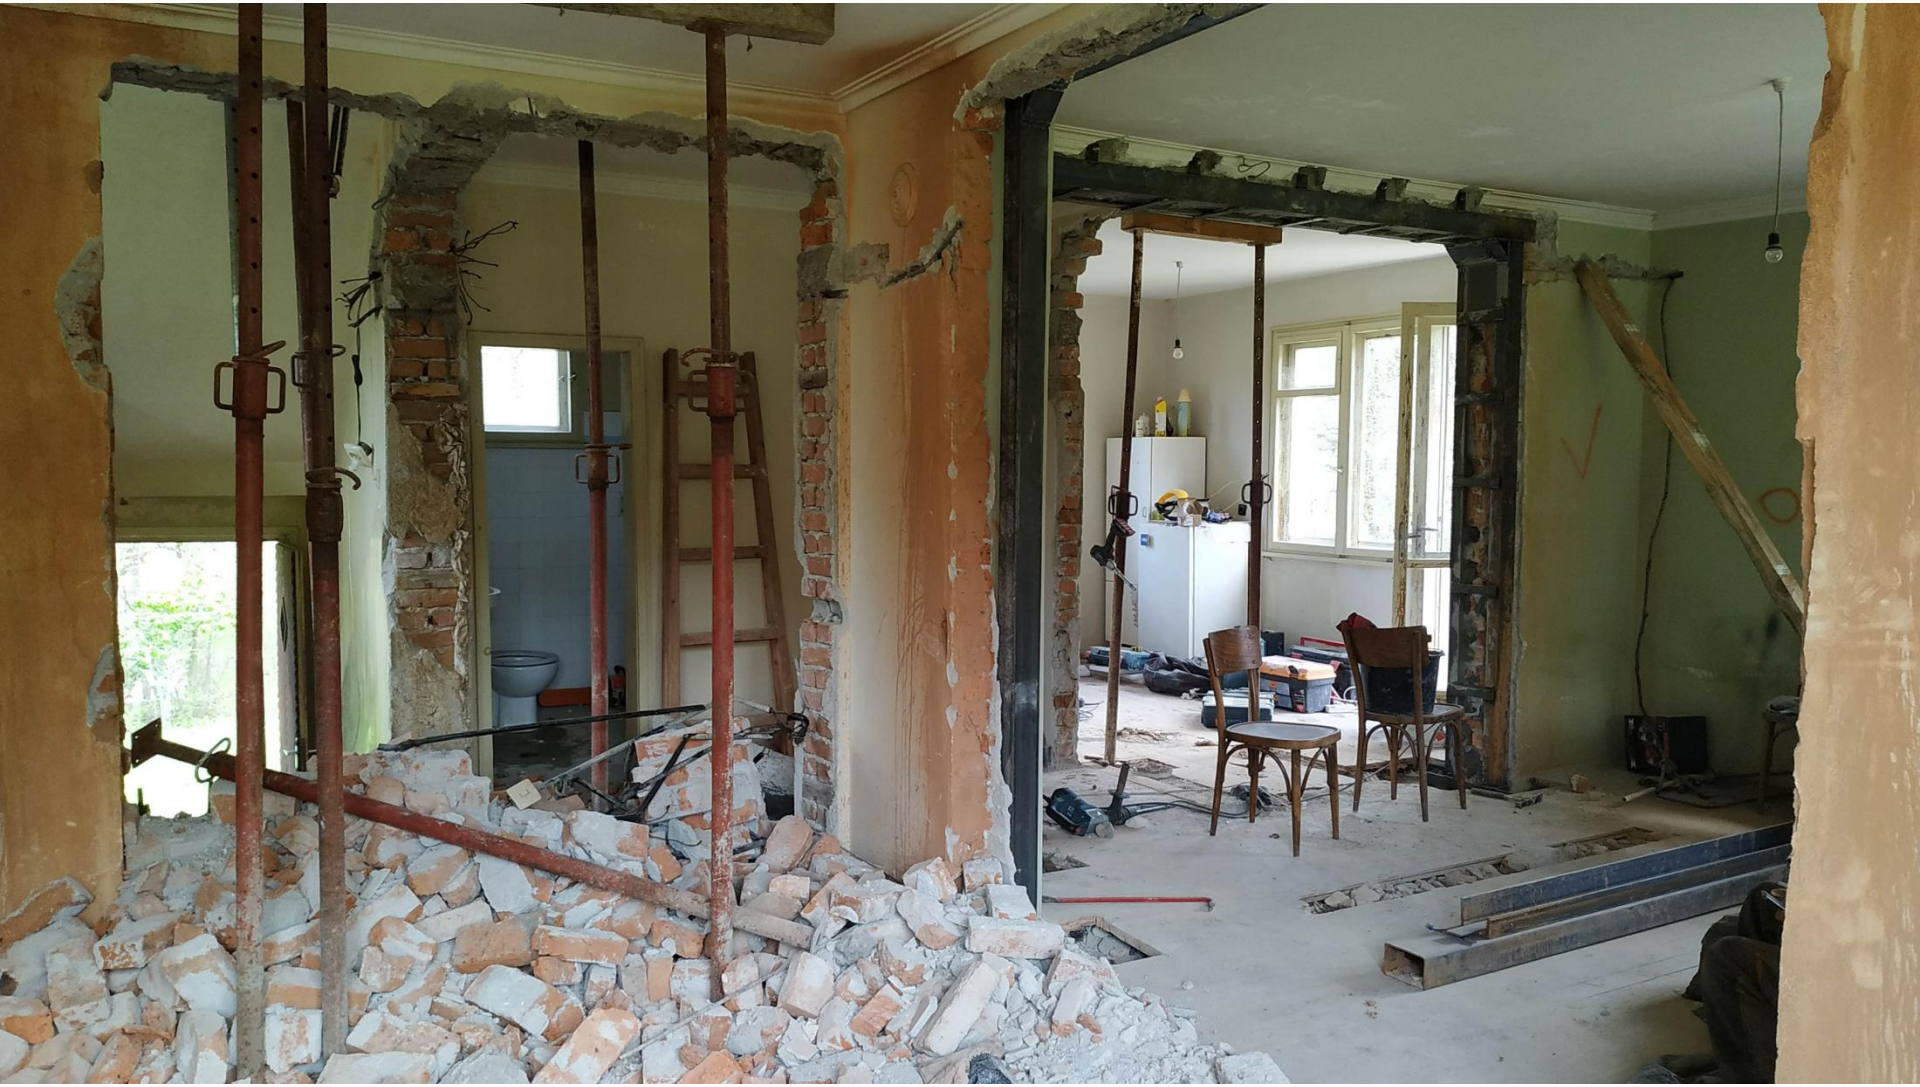
Main causes for appearance of soft floor

- misunderstanding of the role of masonry infills;
- location of destruction- in the masonry or in the surrounding reinforced concrete frame;
- location of masonry infills in plan and height;
- energy dissipation;
- horizontal drift;
- infills with hollow bricks;
- new door or window openings in masonry;
- undesirable formation of short columns and joints.

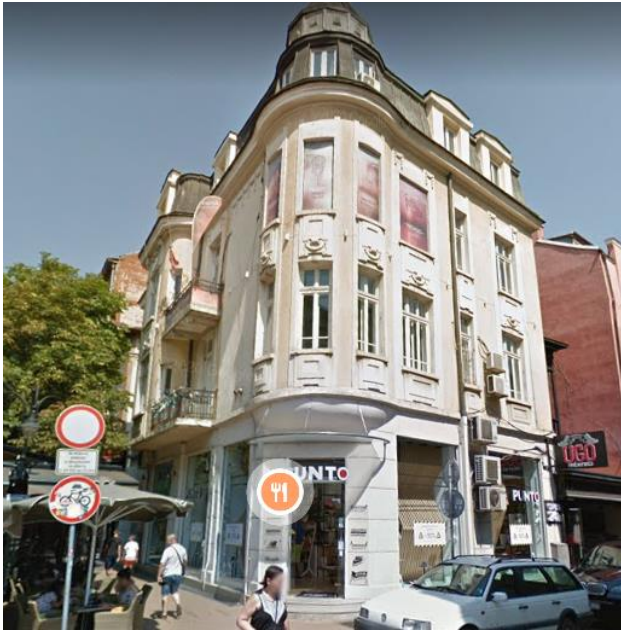
1

For the buildings surveyed in the field study, three basic structural systems were applied:

- **wall bearing system** of masonry with clay or natural stones, wooden floor and roof structures - up to 1920;
- **wall bearing system of solid**, reinforced masonry with reinforced concrete slabs and girders. The last floor level and the roof are of wooden structures – 1920 - 1957;
- **reinforced concrete skeleton** systems with columns, beams and slabs, masonry fillings of solid or hollow bricks. Wooden roof structures - after 1957

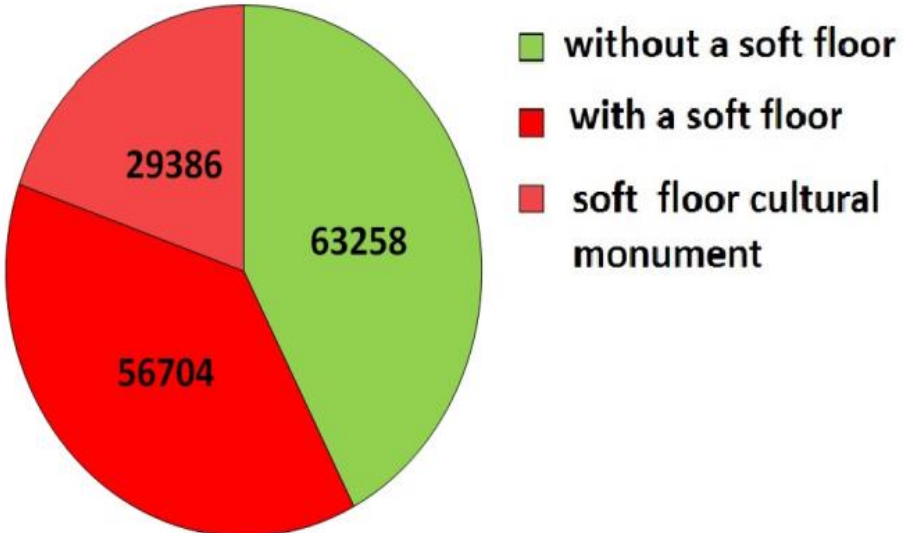
Built-up area in the examined buildings

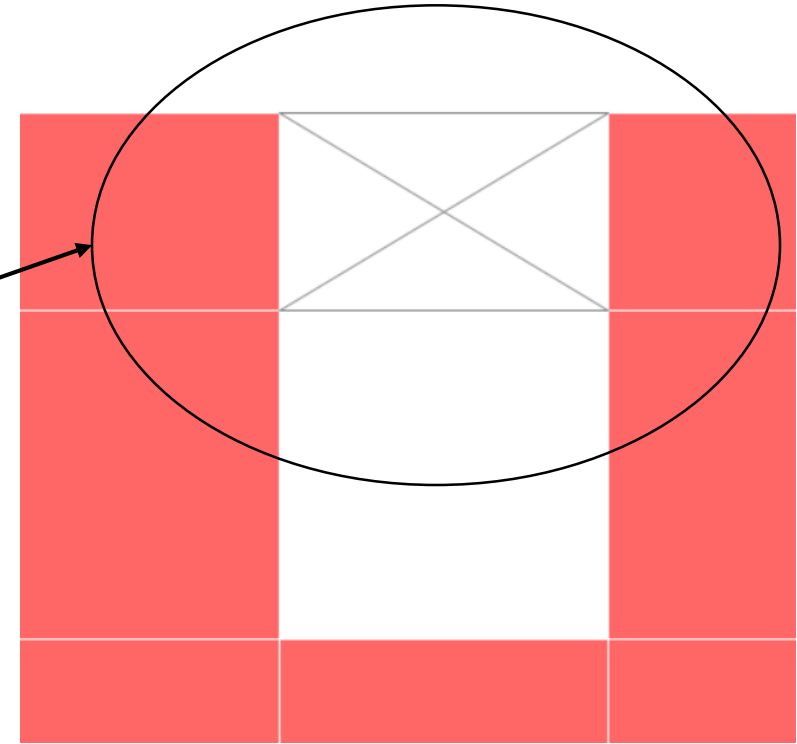
Model 2 Brick masonry walls with line spandrels

- Model 2 is more flexible due to the spandrel's boundary conditions and it simulates the real behavior of the structure more accurately.

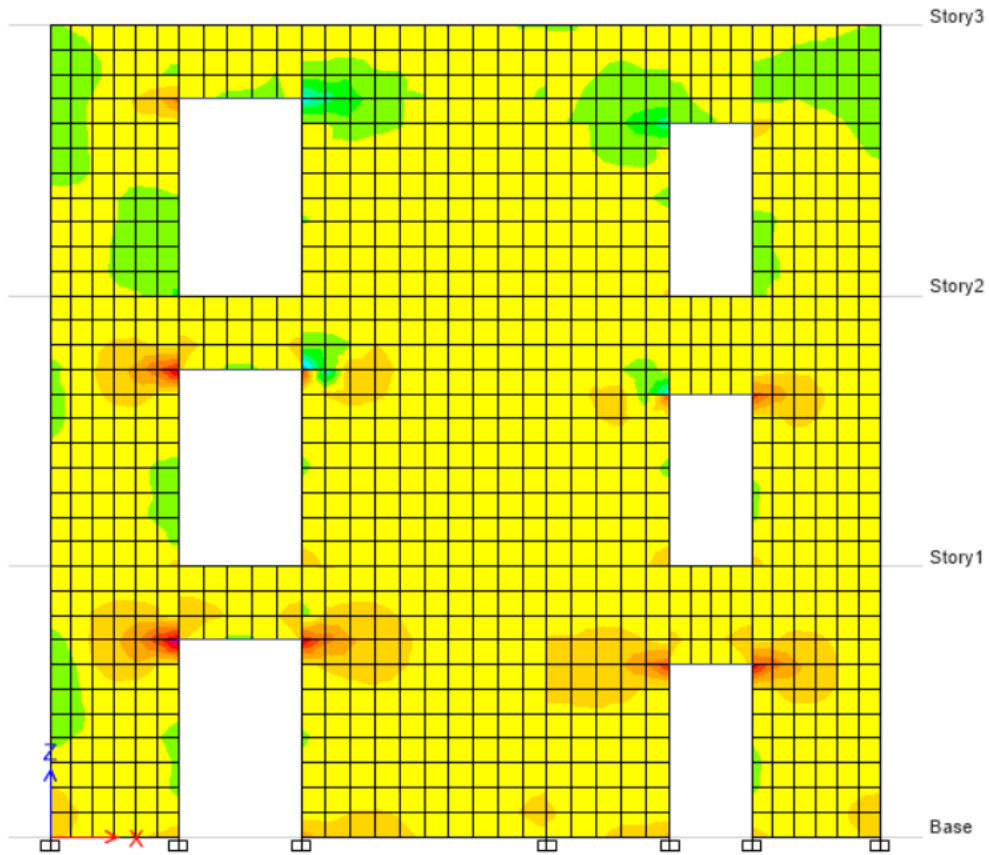
Model 1.2

Interior wall S11 stresses

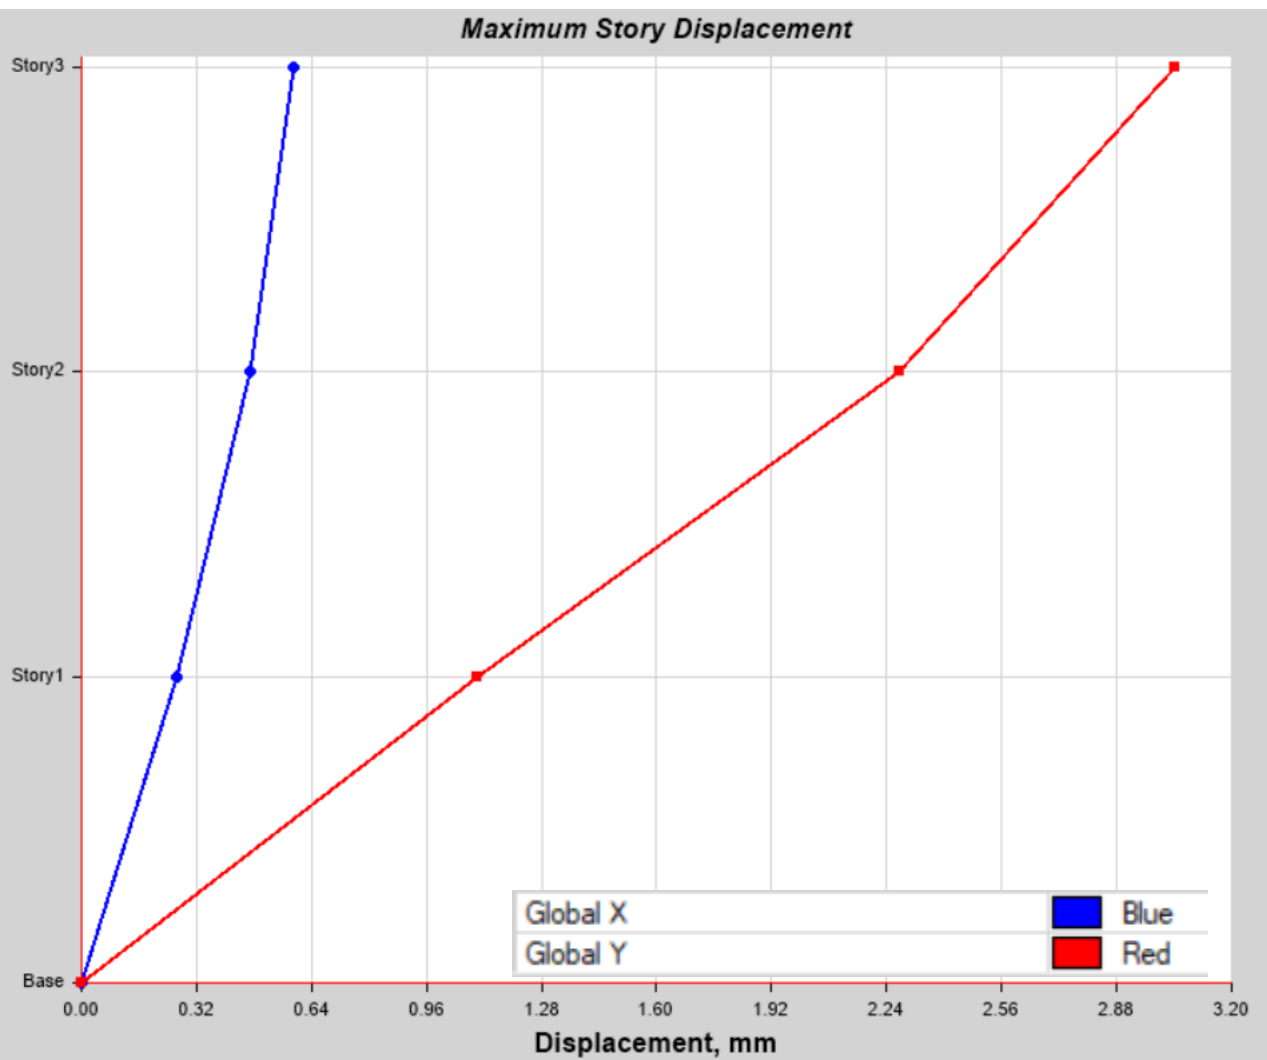
Model 1

Maximum story displacements (earthquake on Y)

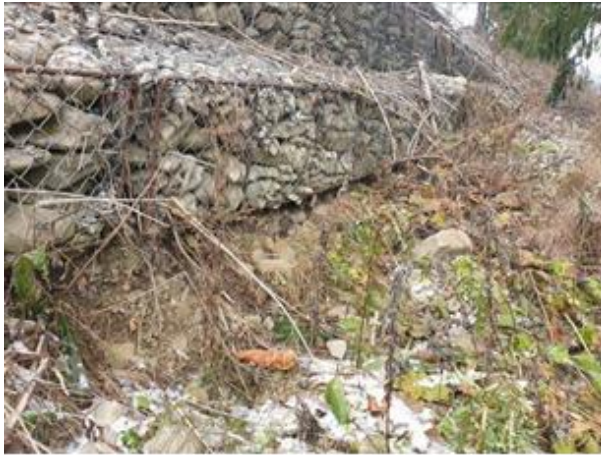
Fig.3-Structura din gabioane

Structura din gabioane nu are fundație corespunzătoare, aceasta prezentând un risc ridicat de cedare în totalitate și risc ridicat de afectare în totalitate sector de drum. (Fig. 3)

Apele curg necontrolat și înmoaie terenul pe sub structura din gabioane existentă. În zona de debleu, șanțul din beton prezintă multiple fisuri și crăpături iar apa colectată se infiltrează prin aceste fisuri în terasamentul drumului.

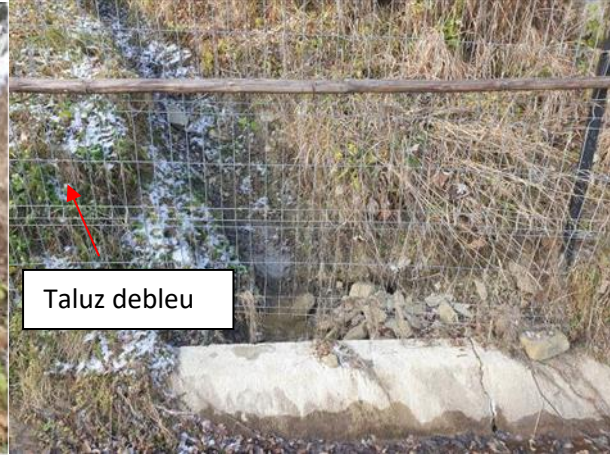
Fig.4-Zona de debleu

Pe zona de debleu, a fost identificat un taluz cu multiple ravene. Apa provenită de pe taluz nu este colectată în totalitate de șanțul din beton. (Fig. 4)

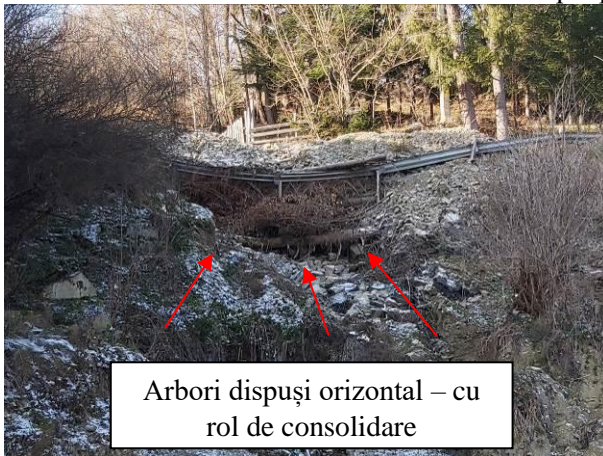
Fig. 5 – Arbori dispuși in corpul drumului

În corpul drumului au fost dispuși arbori cu rol de consolidare temporară (Fig. 5). Pe zona de aval sunt evidențiate aceleași particularități prezentate pe zona 1.

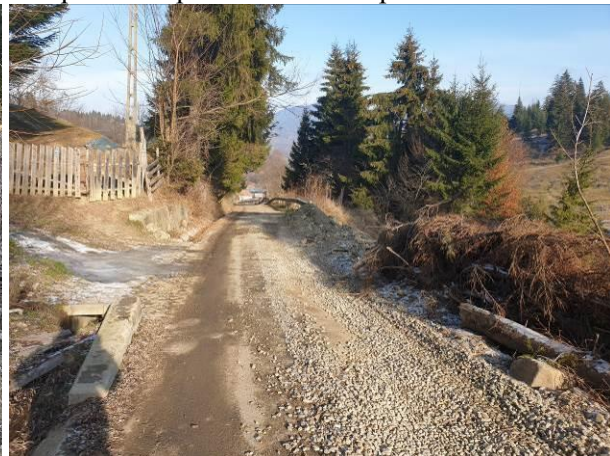
Fig. 6 – Corpul drumului

Corpul drumului este afectat de forme de cedare, circulația se desfășoară cu dificultate. (Fig. 6)

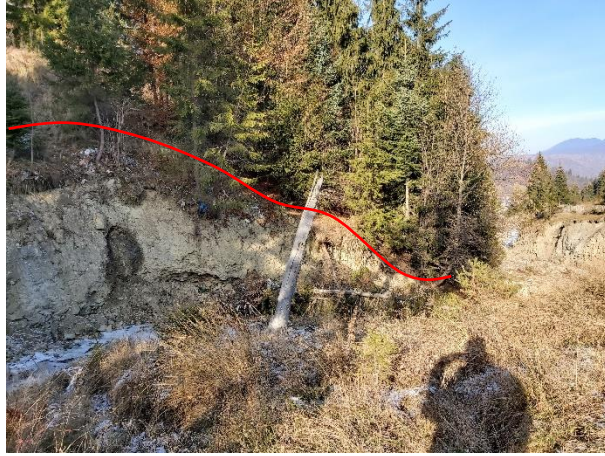
Fig. 7 – Zonă neafectată

Prezintă aceleași particularități ca zona 2.1. cu avantajul că există pe taluzul de rambleu o vegetație arboricolă mai densă care nu a fost afectată de alunecare, iar drumul se prezintă în condiții acceptabile, fără a fi identificate forme de cedare. (Fig. 7)

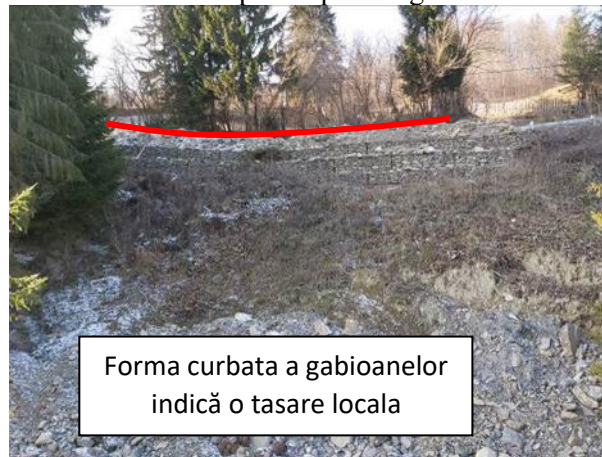
Fig. 8 – Tasare la nivelul gabioanelor

La nivelul drumului au fost observate forme de tasare accentuată. Sectorul de drum este consolidat cu gabioane, cu fundația în zona mediană a taluzului. Au fost evidențiate forme de tasare accentuată la nivelul gabioanelor. Zona de aval prezintă aceleași particularități ca la zona 1. (Fig. 8)

Taluzul de rambleu prezintă forme de eroziune care pun în pericol gabioanele existente din acea zonă.

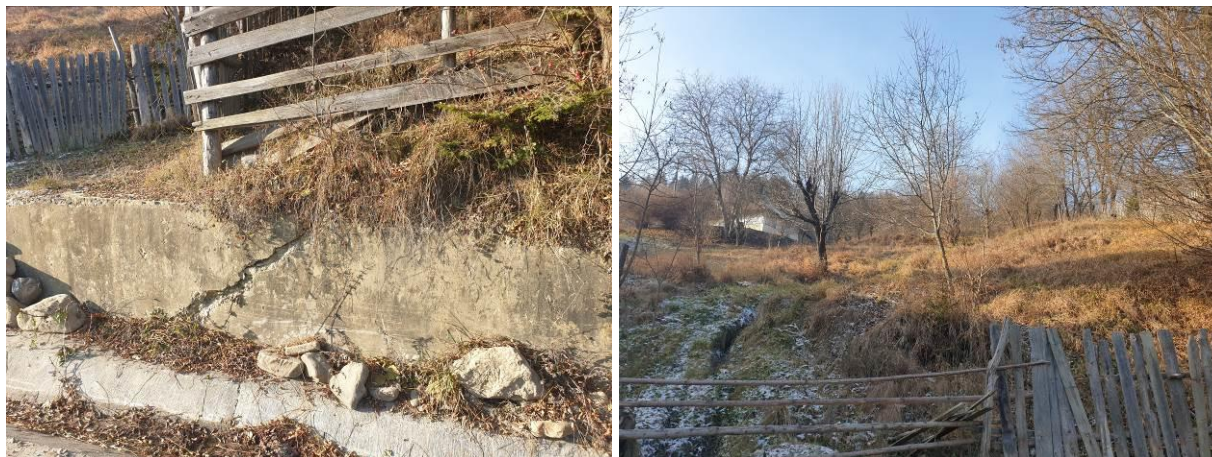
Fig. 9 – Zona de debleu al drumului

Pe zona de debleu au fost identificate mai multe zone de ravenare – descărcare ape de versanți. Aceste zone nu sunt amenajate și transportă material detritic în zona drumului iar șanțurile existente, longitudinale drumului sunt degradate, crăpate. Apa care provine de pe versant descarcă necontrolat în zona șanțurilor, pe majoritatea zonelor aceasta se infiltrează pe sub șanțul existent și migrează către zona de aval ajungând în zona fundațiilor gabioanelor.

Zona de amonte are un aspect frământat și pe alocuri prezintă ușoare forme de eroziune. (Fig. 9)

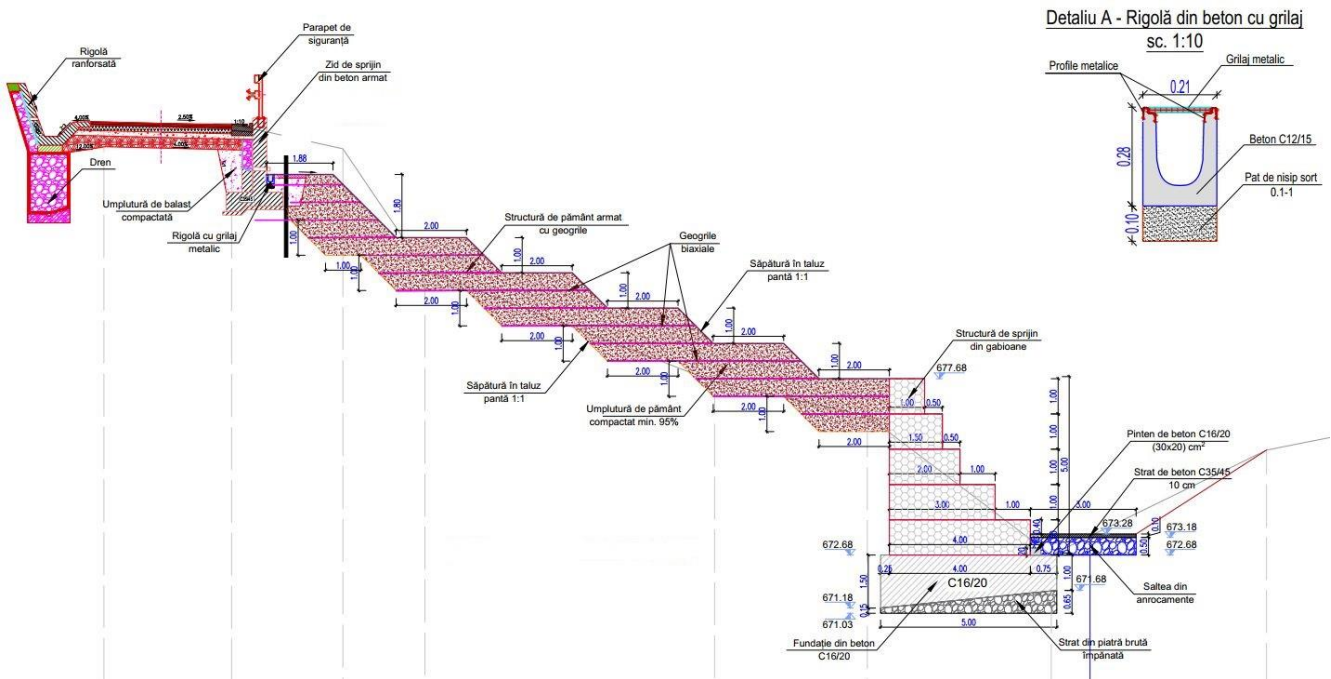
Fig. 10 – Profil transversal cu lucrările proiectate

Ca material de umplutură se va folosi pământ local. Vor fi compactate la umiditatea optimă de compactare determinată în laborator prin încercarea Proctor.

Pentru asigurarea stabilității zonei, în locul fostelor sprijiniri existente (gabioane), s-a proiectat un zid de sprijin din beton armat, pe aproximativ aceeași lungime. Pentru reducerea presiunii hidrostactice asupra structurii de sprijin, în spatele zidului se va realiza un sistem de drenaj vertical cu filtru învelit în material geotextil.

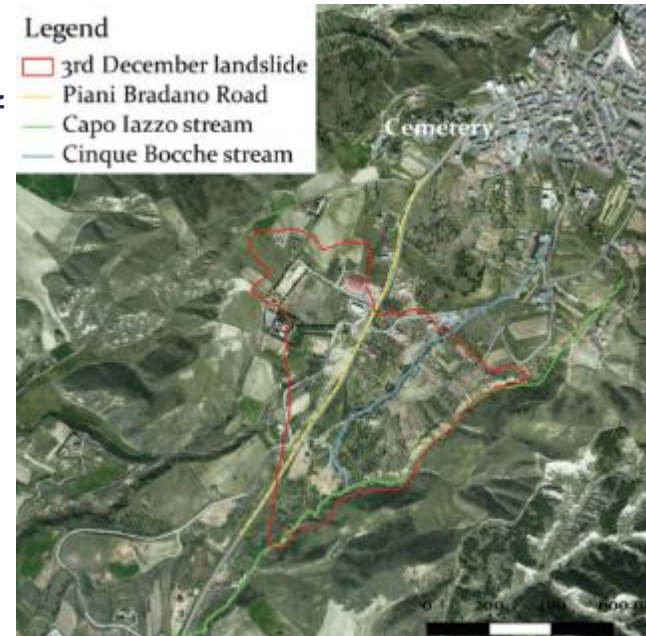
Area involved in the 3rd December Montescaglioso landslide

- The 3rd December landslide had a complex manifestation. The evidences of ground failures were collected at 01.00 PM of the same day, in proximity of the main road (namely Piani Bradano road), for a length of about 500 m. In the following hours, several private houses have been damaged, as proved by displacement up to 6 m of their foundations. However, some damages were documented by local witnesses in private areas the day before the event localized at the toe of the landslide (Pellicani et al. 2016). The last phase of the movement (occurred in the night between the 3rd and 4th December) was typified by a retrogressive style, causing a northward replacement of the landslide area.

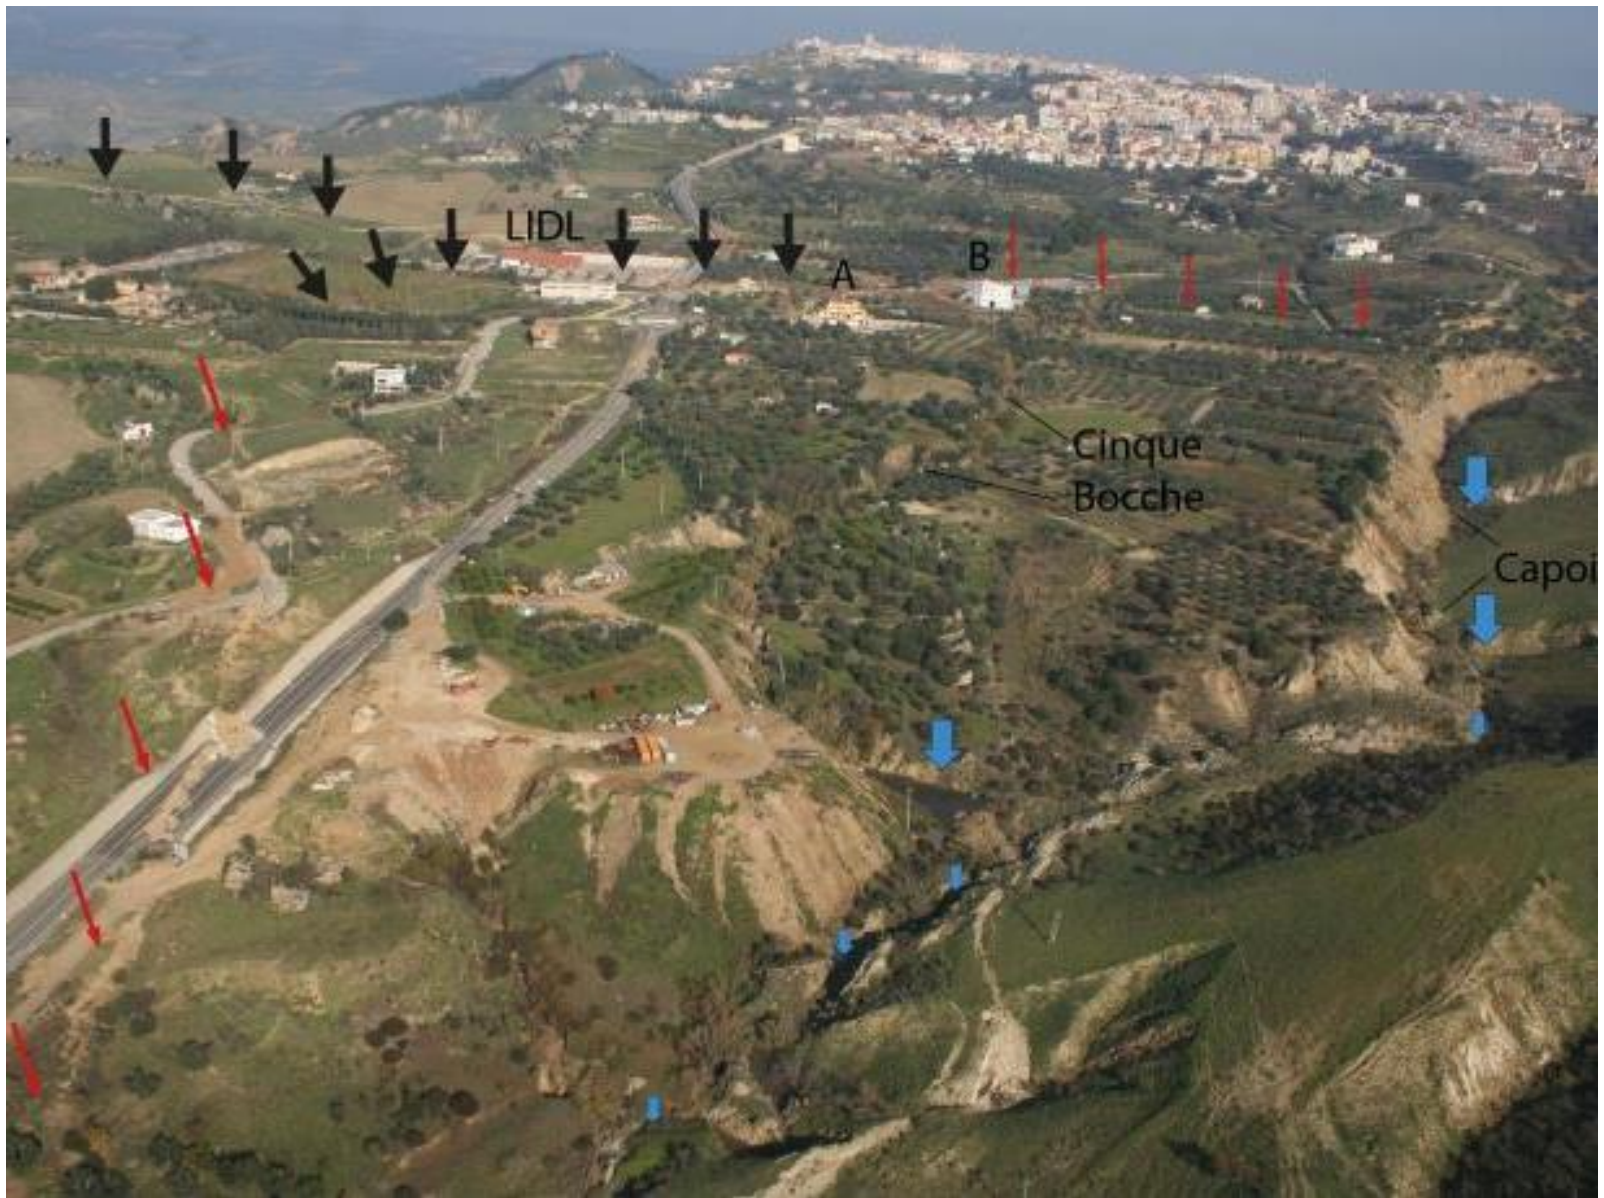
-   The December 03, 2013, Montescaglioso event
-   Anthropogenic scarp
-   Crack with evidence of strike-slip movement
-   Narrow crack
-   Pressure ridge
-   Scarp
-   Small landslide
-   Tension crack
-   Uphill-facing scarp
-   Water line
-   Pond
-   Trench
-   Highly disturbed area

- Products:
- Map of surface deformations produced by the landslide. Thematic maps on landslide inventory, and multi-temporal maps of the slopes affected by the 2013 landslide. Weekly bulletin of topographic monitoring. Monthly bulletin of inclinometric monitoring.

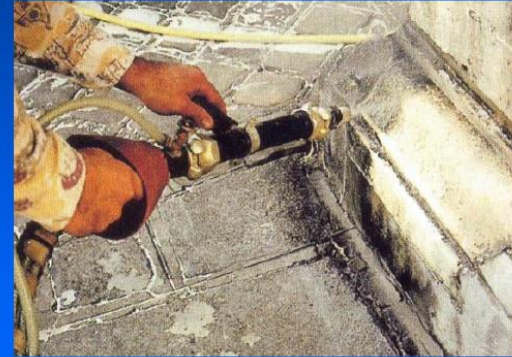
- Le gommage ®

projection d'une fine poudre (ϕ 30 à 100 μ m) sous faible pression (avec ou sans eau)

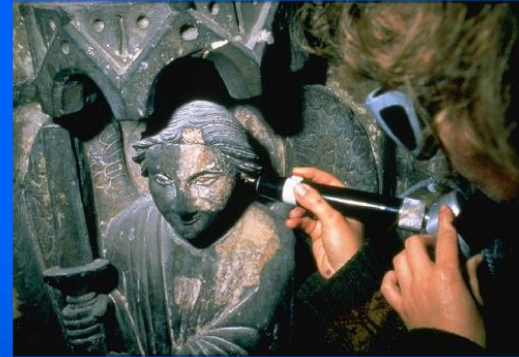
- Le nettoyage laser

vaporisation des salissures en surface par l'impact d'un faisceau laser à impulsions

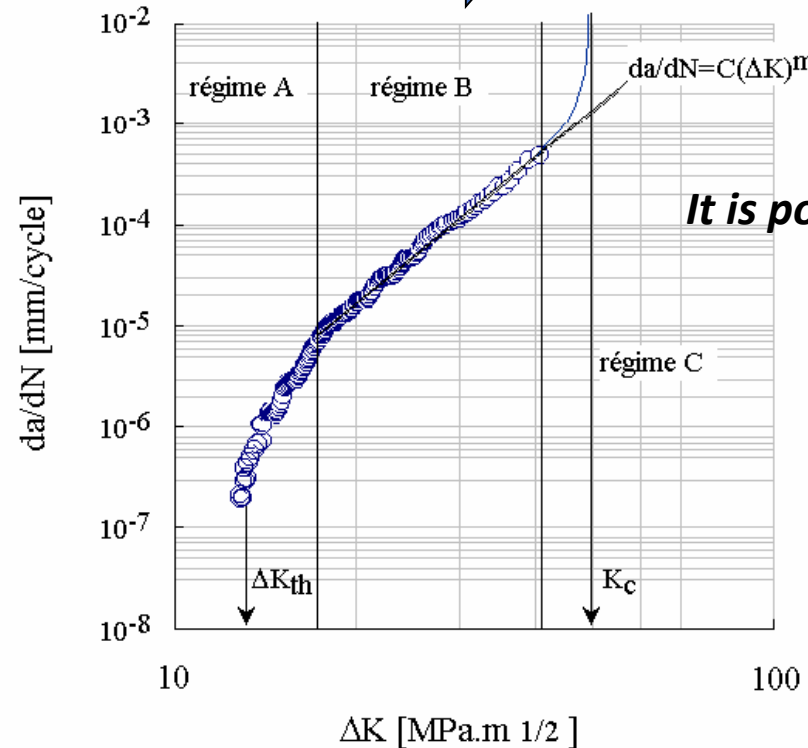
Damage by fatigue ? Subcritical crack growth ?

Paris law of fatigue :

It is possible to make prediction of time to failure

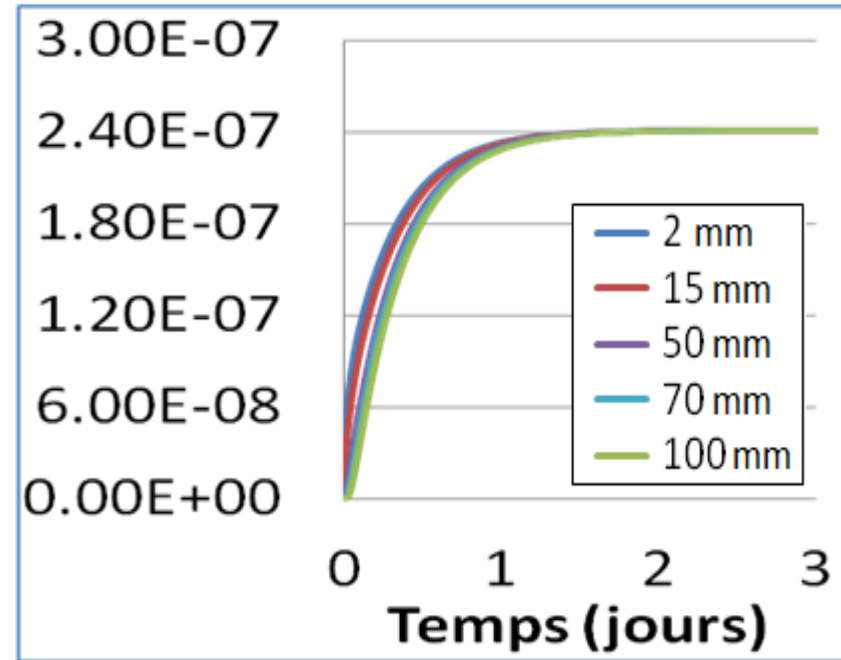
SO₄²⁻

➤ Increase of Ca²⁺ and SO₄²⁻ concentration

➤ **But not gypse precipitation!!**

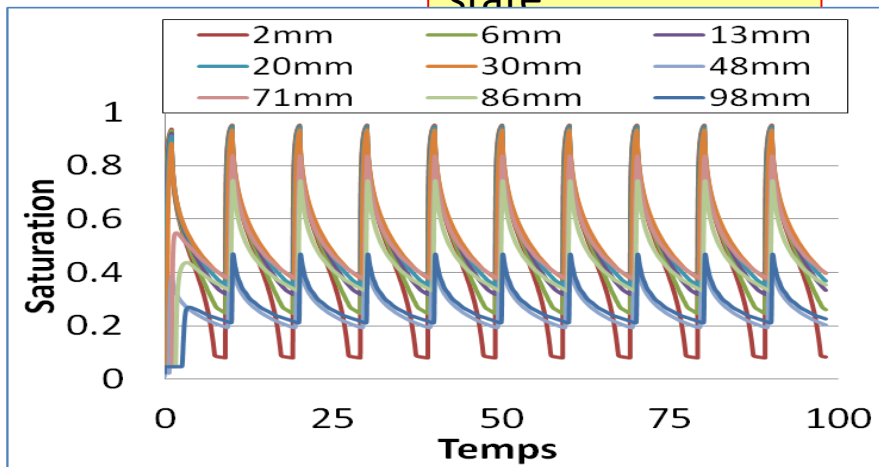
➤ Variation en cycle pluie-séchage
